MEMORANDUM

To:	Valmichael Leos and Anne Foster, USEPA	Date:	February 21, 2014
From:	Wendell Mears, Randy Brown, David Keith, John Verduin, and John Laplante	Project:	090557-01.04
Cc:	Dave Moreira and Andrew Shafer, MIMC Phil Slowiak, IP		
Re:	San Jacinto River Waste Pits TCRA Armored Cap Enhancement Completion Report

This document provides a summary of enhancement activities with respect to the armored cap protective cover installed as part of the Time Critical Removal Action (TCRA) at the San Jacinto River Waste Pits (SJRWPs) Superfund Site (TCRA Site). Construction of armored cap enhancements for protective cover occurred from January 17 through 27, 2014; inspection of material gradations in the armored cap enhancement areas was completed on February 13, 2014.

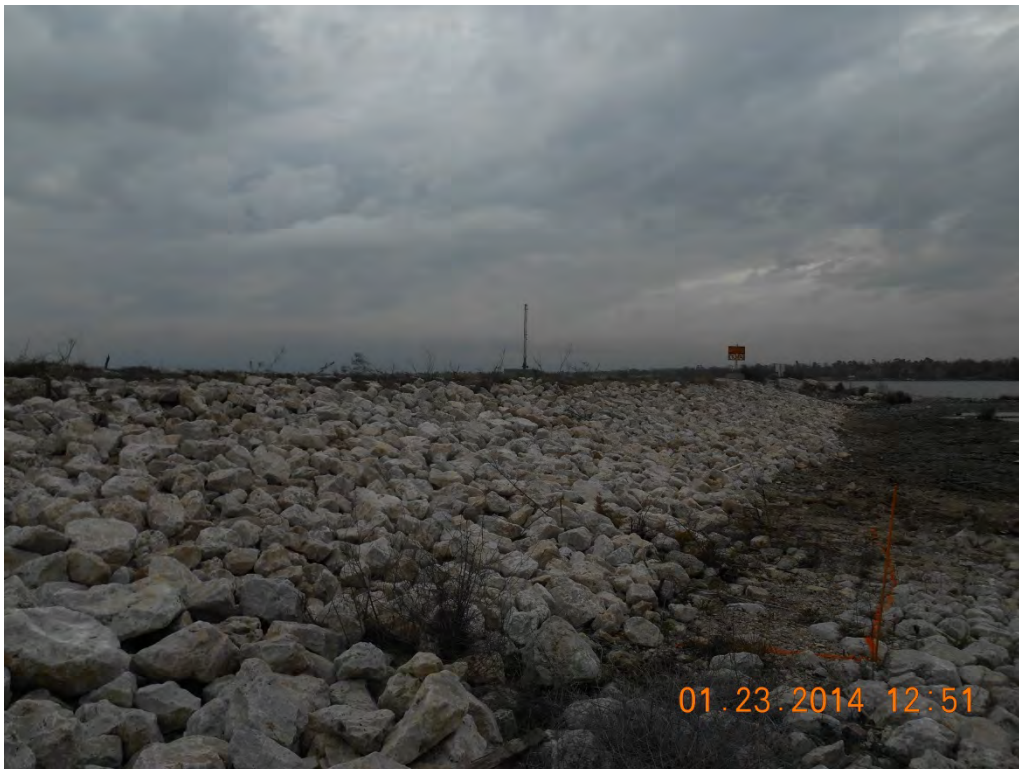
Photo 4 – Post-enhancement slope of Area #4 on the eastern slope of the Central Berm.

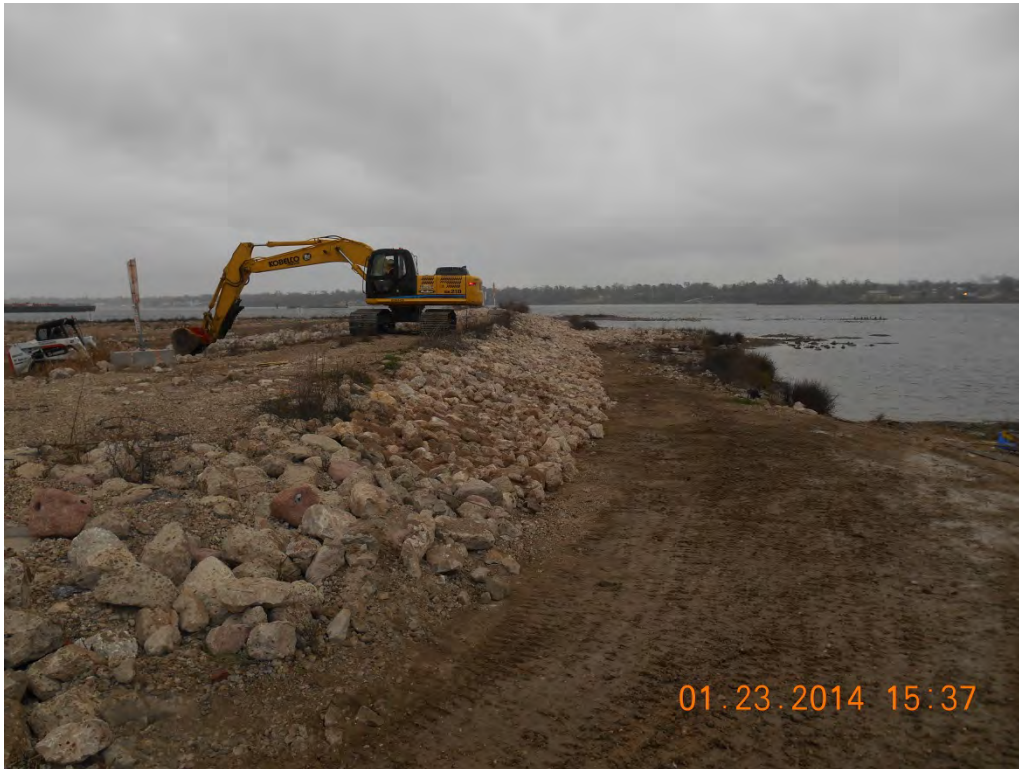
Photo 5 – Rock placement in progress at Area #5 on the eastern slope of the Central Berm.

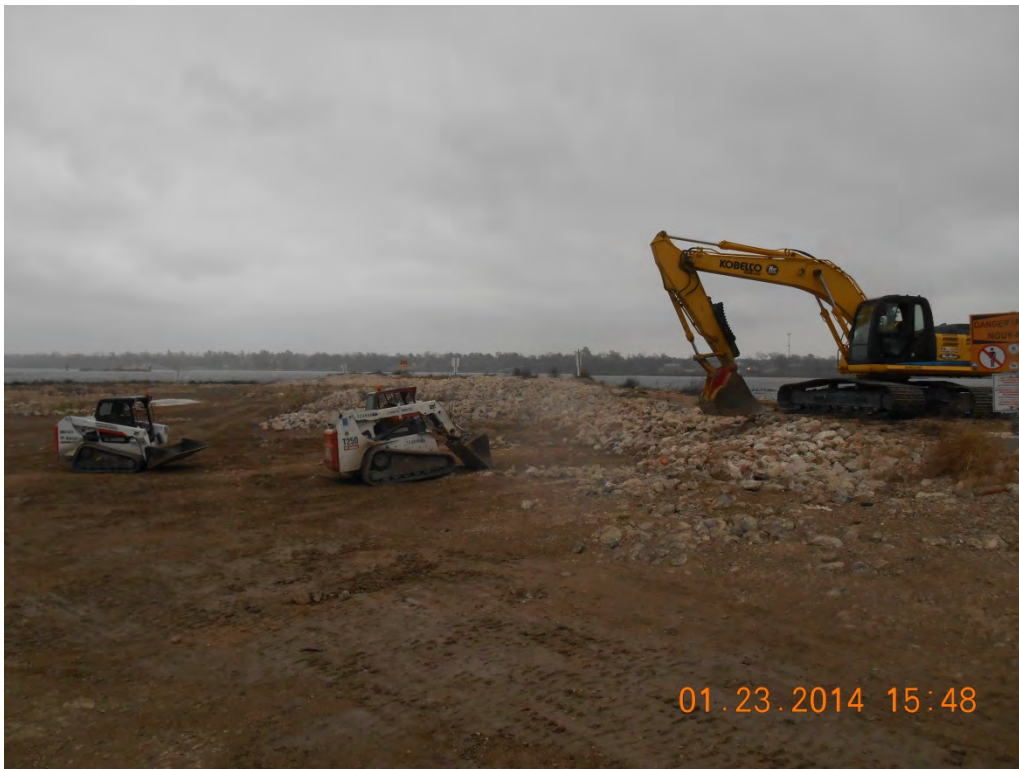
Photo 6 – Rock placement in progress at Area #7 on the western slope of the Central Berm.

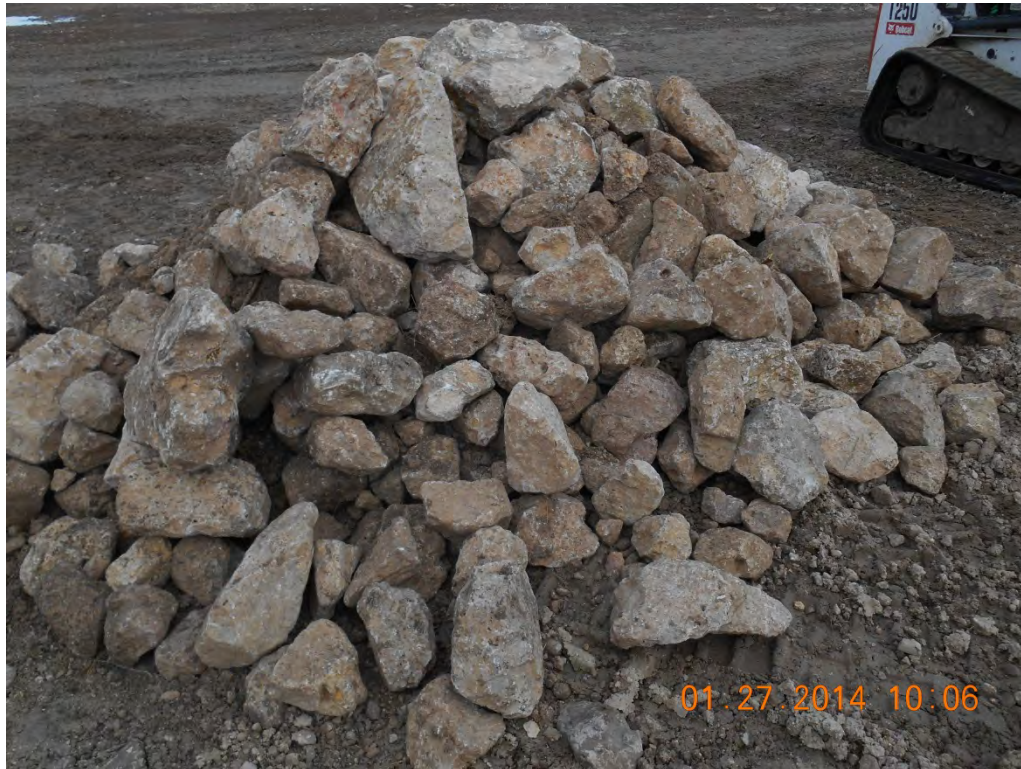
Photo 1 – Close-up of Armor Cap D rock at the on-site stockpile area.

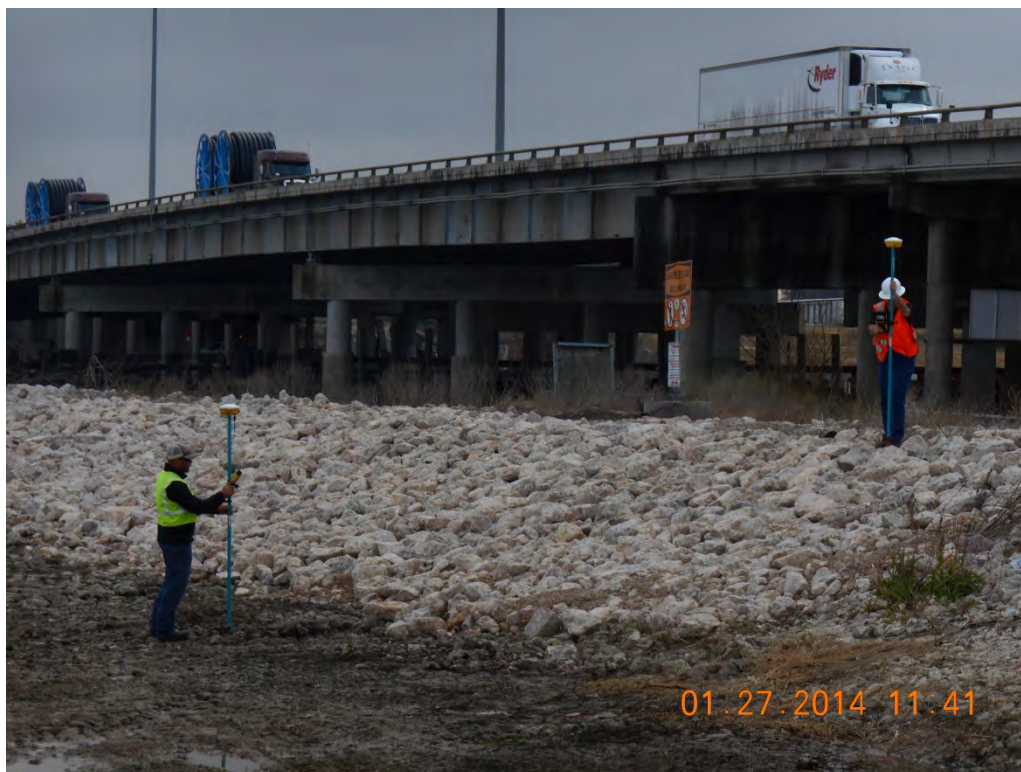
Photo 2 – Collecting survey data along the South Berm at Area #1.

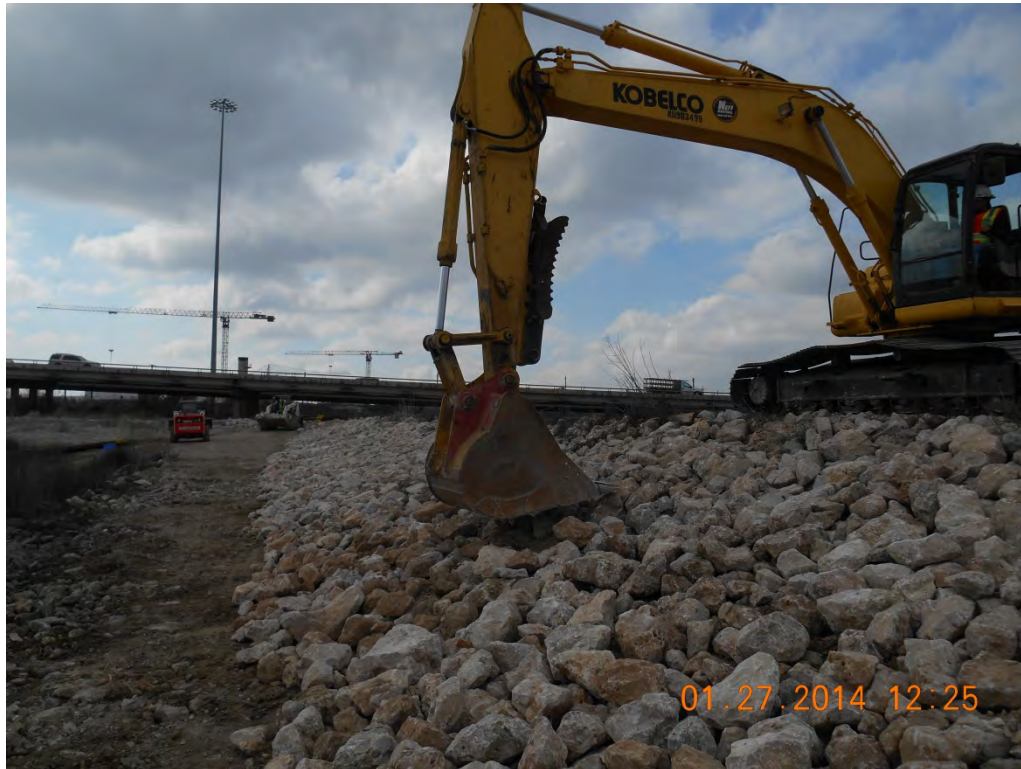
Photo 3 – Grading Armor Cap D rock on the eastern slope of the Central Berm in Area #5.

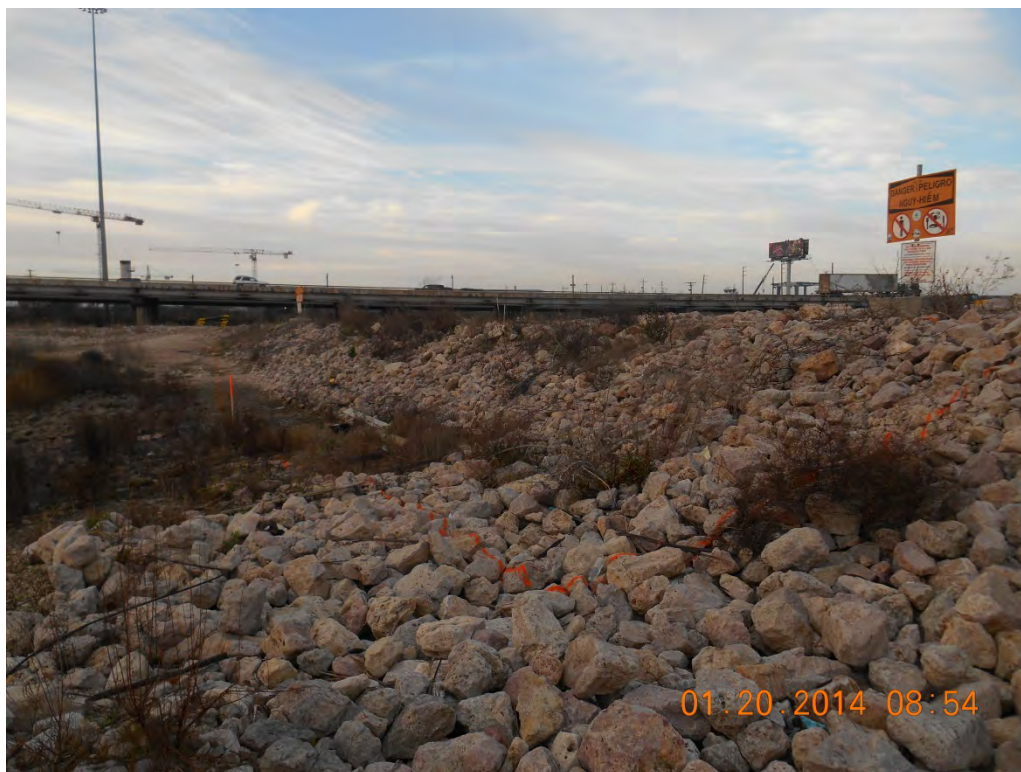
Photo 4 – Pre-enhancement slope of Area #5 on the eastern slope of the Central Berm.

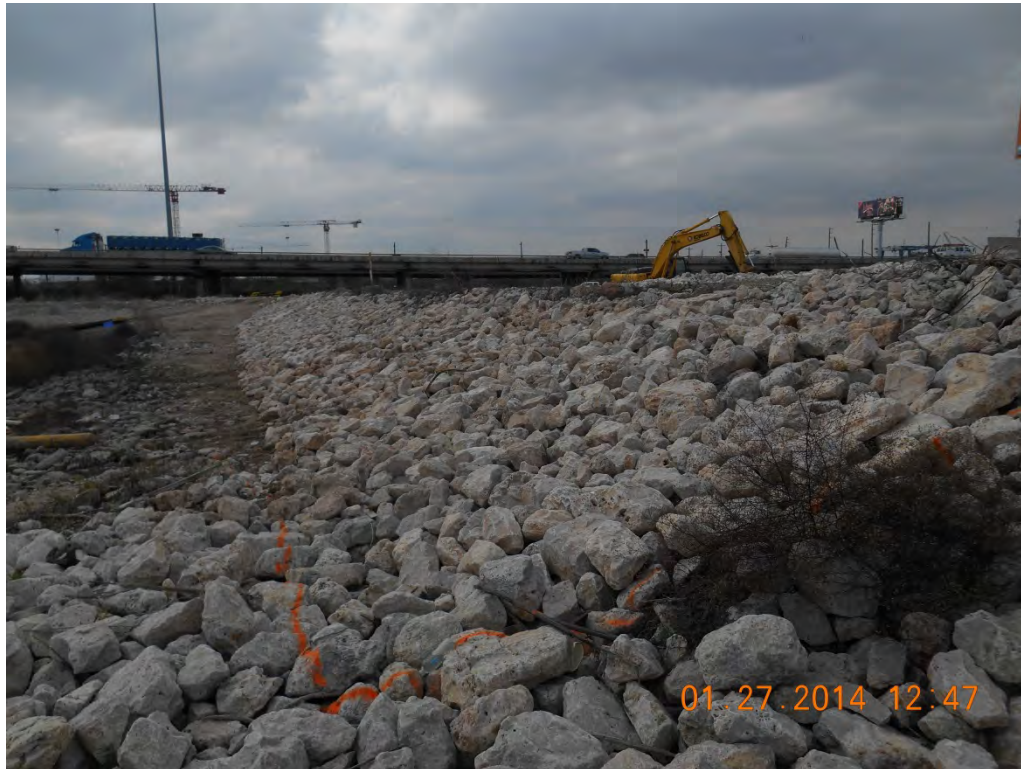
Photo 5 – Post-enhancement slope of Area #5 on the eastern slope of the Central Berm.

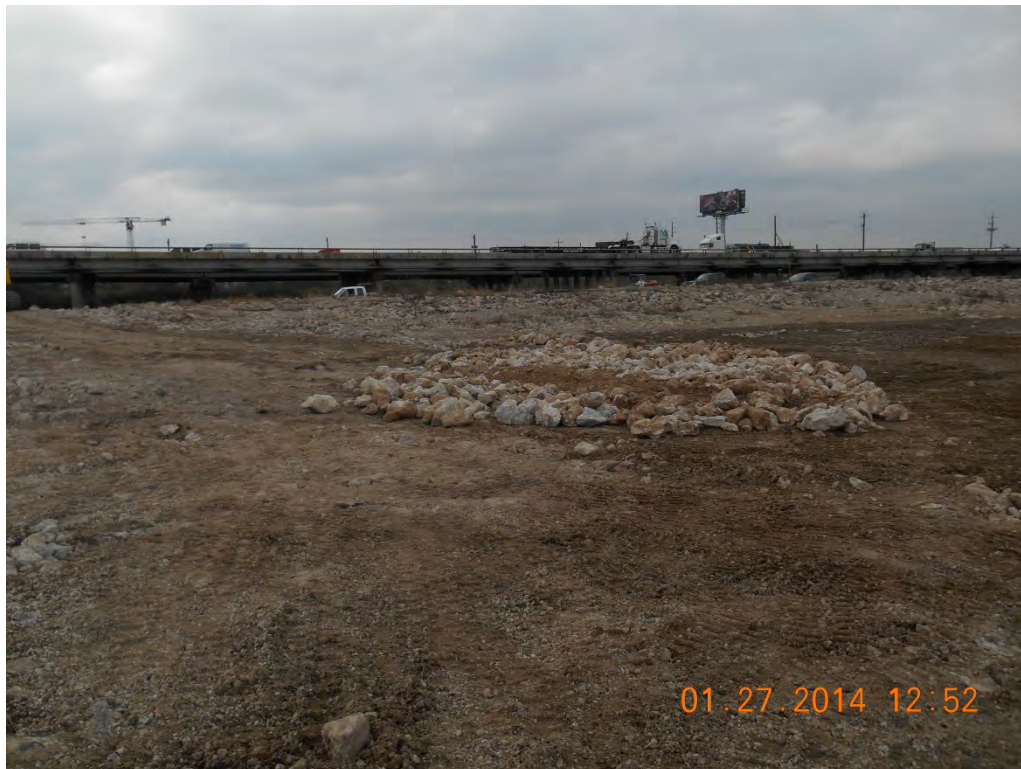
Photo 6 – Armor Cap D rock spread across the stockpile area in the southeast corner of the Western Cell.
